Manhole Inspection Summary

Manhole # S17I__017MH

Location Address: **2454 BALTIMORE ST**

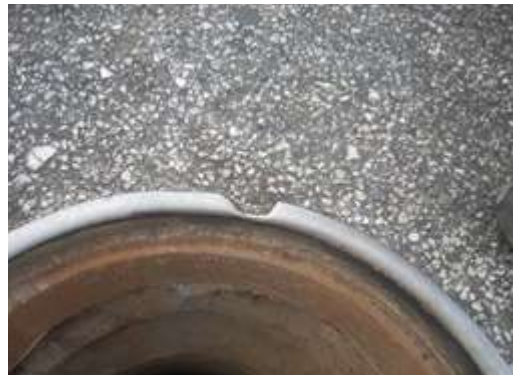
Condition: **Worn**

worn frame

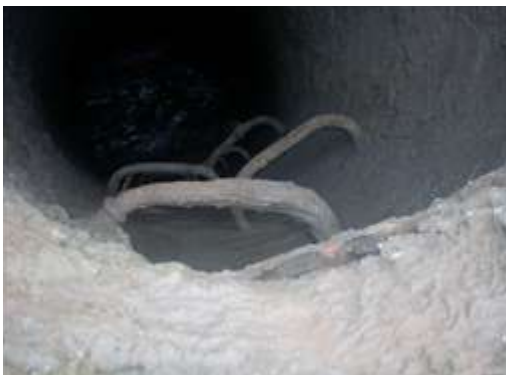
Defect 4

Count: **12** Missing: **0** ☒ **Corroded**

CORRODED STEPS

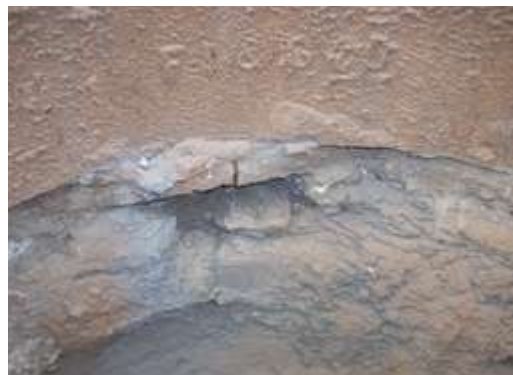
Defect 3

Condition: ☐ Sound ☐ Cracked ☐ Root Intrusion ☐ Loose Brick ☒ **Deteriorated**

DETERIORATED CHIMNEY

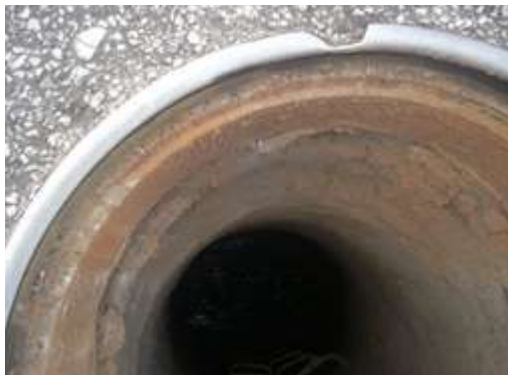
Defect 2

Offset: **3** (in.)

FRAME OFFSET

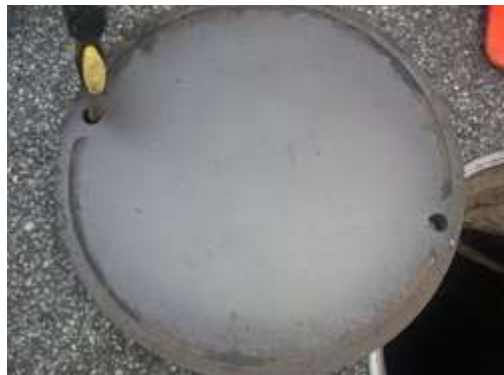
Defect 1

WORN COVER

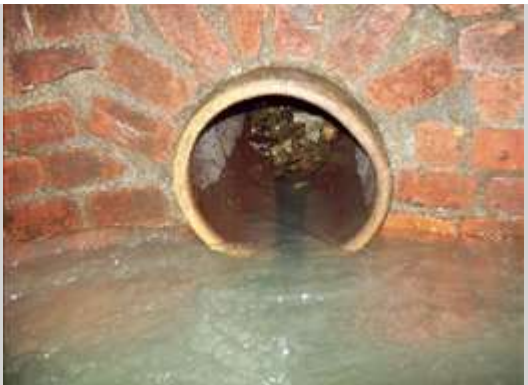
3 O'Clock Inflow

Pipe Height: **8.4** (in.) Direct (Angled)
Pipe Material: **Clay** ☐ Pipe Lined
Invert Depth: **16.71** (ft.) Flow Characteristics: **None**
Deposits: ☐ None ☐ Mud ☐ Sludge ☒ **Debris** ☐ Grease
Silt Depth: **3.5** (in.) Deposits Extent: **Medium**
Infiltration: **None** Pipe Seal Cond: **Sound**
